Flettons

ROOF REPORT

Dr John Smith

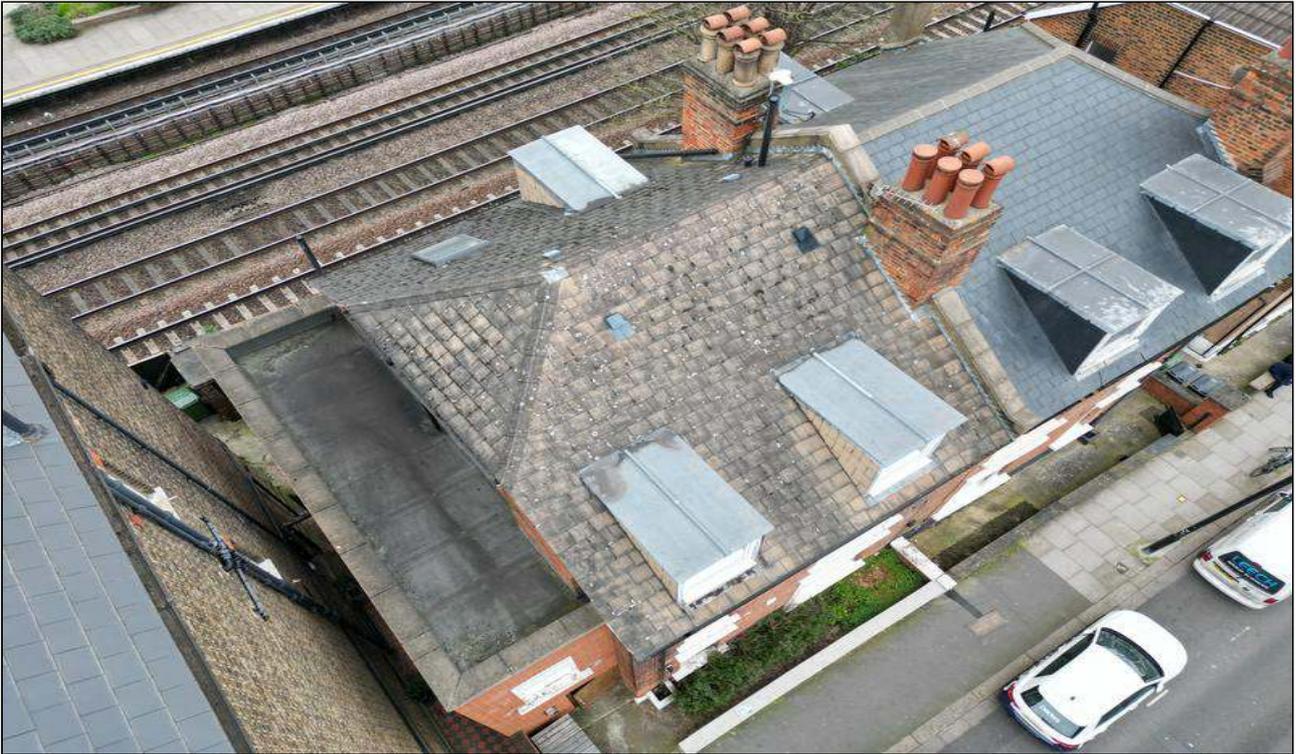
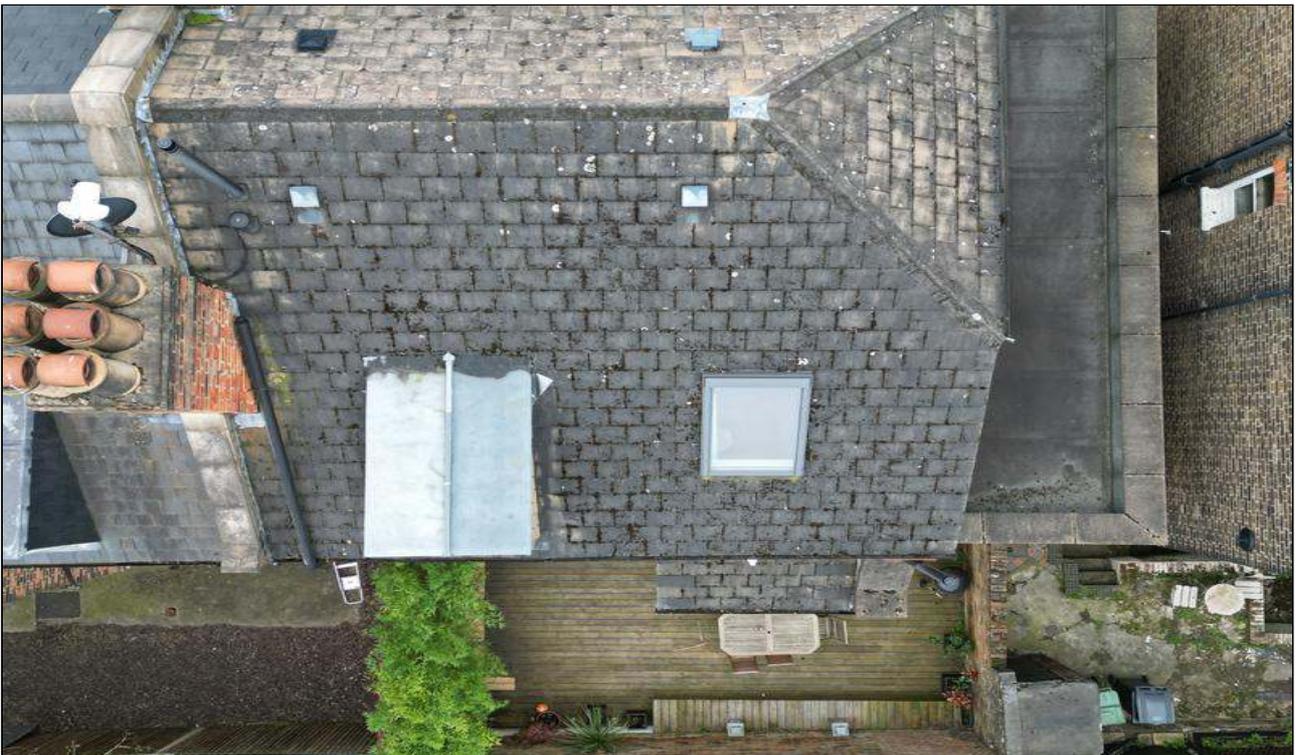
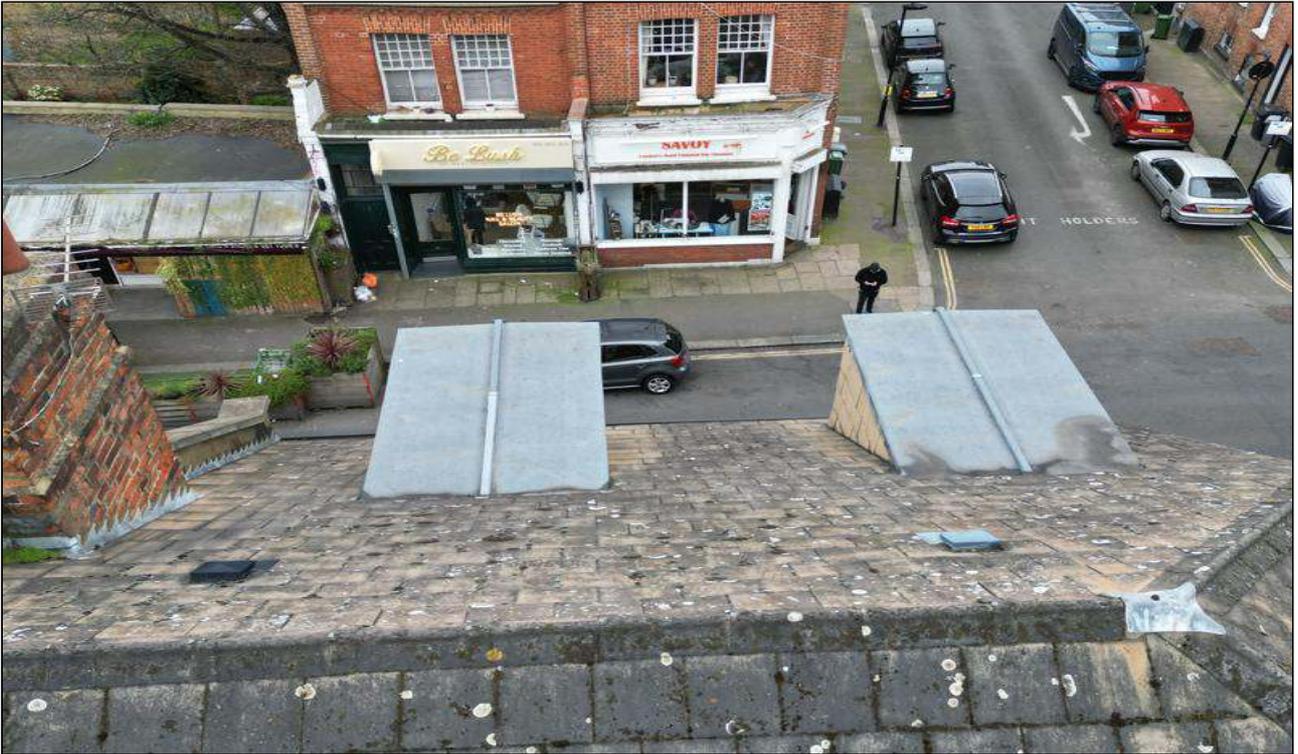
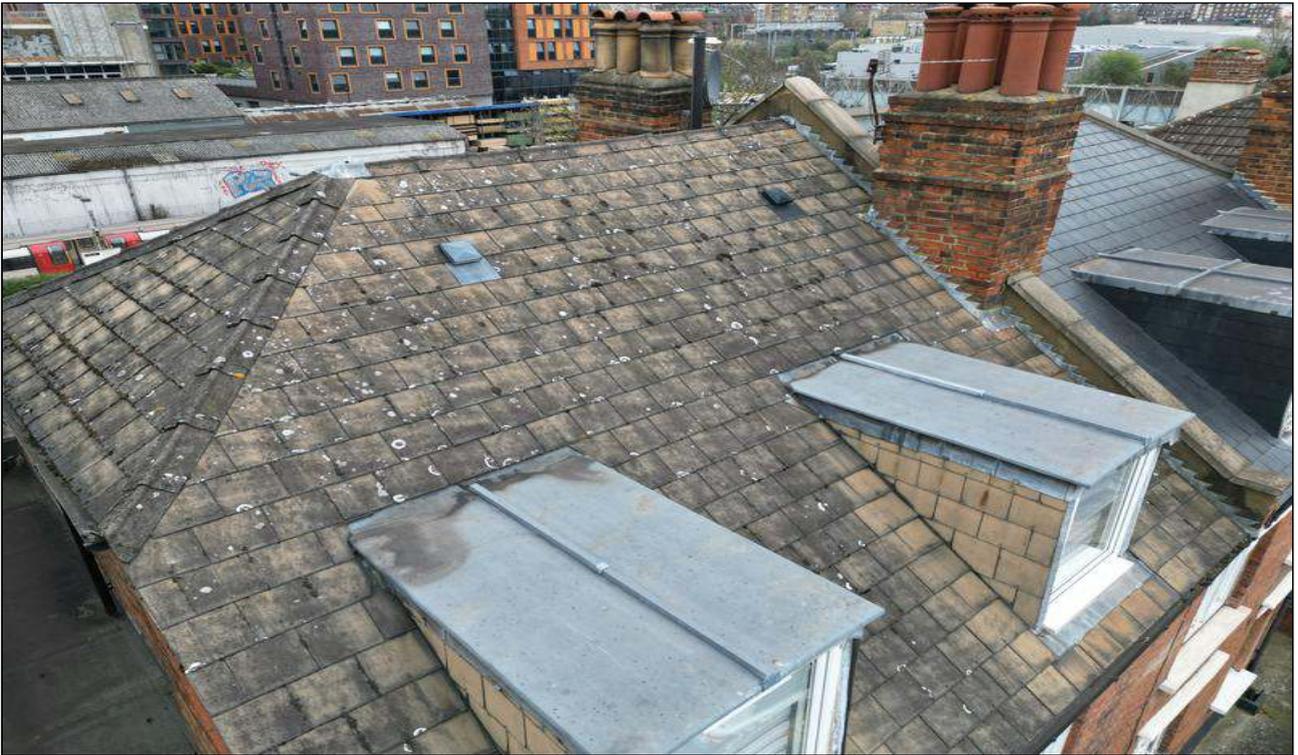
5.1 MAIN ROOF

CONDITION RATING: 2

The roof of the property is constructed with a pitched design and covered with Marley Eternit fibre cement tiles, which are nearing the end of their typical lifespan of up to 40 years. These tiles might contain asbestos, and it is advised to conduct an asbestos survey to confirm their composition. The presence of asbestos could significantly increase the cost of future roof replacements due to the requirements of the Control of Asbestos Regulations. It is important to use a licensed contractor for handling and disposal of any asbestos-containing materials.

Currently, the roof appears to be in satisfactory condition for its age, estimated at around 40 years, but annual inspections are recommended to monitor its condition. The roof covering's remaining life expectancy is projected to be up to 5 years, assuming ongoing maintenance and repair. Despite its present adequate condition, the roof is approaching the end of its serviceable life, and there is no guarantee regarding its longevity or continued waterproofing effectiveness. Regular maintenance and timely repairs are crucial to prevent potential leaks and associated damp issues.

Moss growth has been observed on the tiles, which could lead to damage and blockages affecting surface water drainage. It is recommended to remove any moss by a professional to prevent these issues. Given the age and condition of the roof, planning for its replacement within the next few years is advisable to avoid potential problems such as water ingress, mold development, and structural safety hazards. Delaying the replacement could also complicate obtaining insurance coverage, potentially leading to higher premiums or difficulty in securing a policy.

Routine annual inspections of the roof are essential to preserve its integrity and extend its lifespan. These checks allow for the early detection and remediation of minor issues such as cracks or weather damage, thereby preventing costly major repairs. They also help in fulfilling some insurance policy requirements, ensuring coverage continuity. Regular maintenance not only helps in extending the roof's life but also in safeguarding the property against unexpected repairs and financial losses.

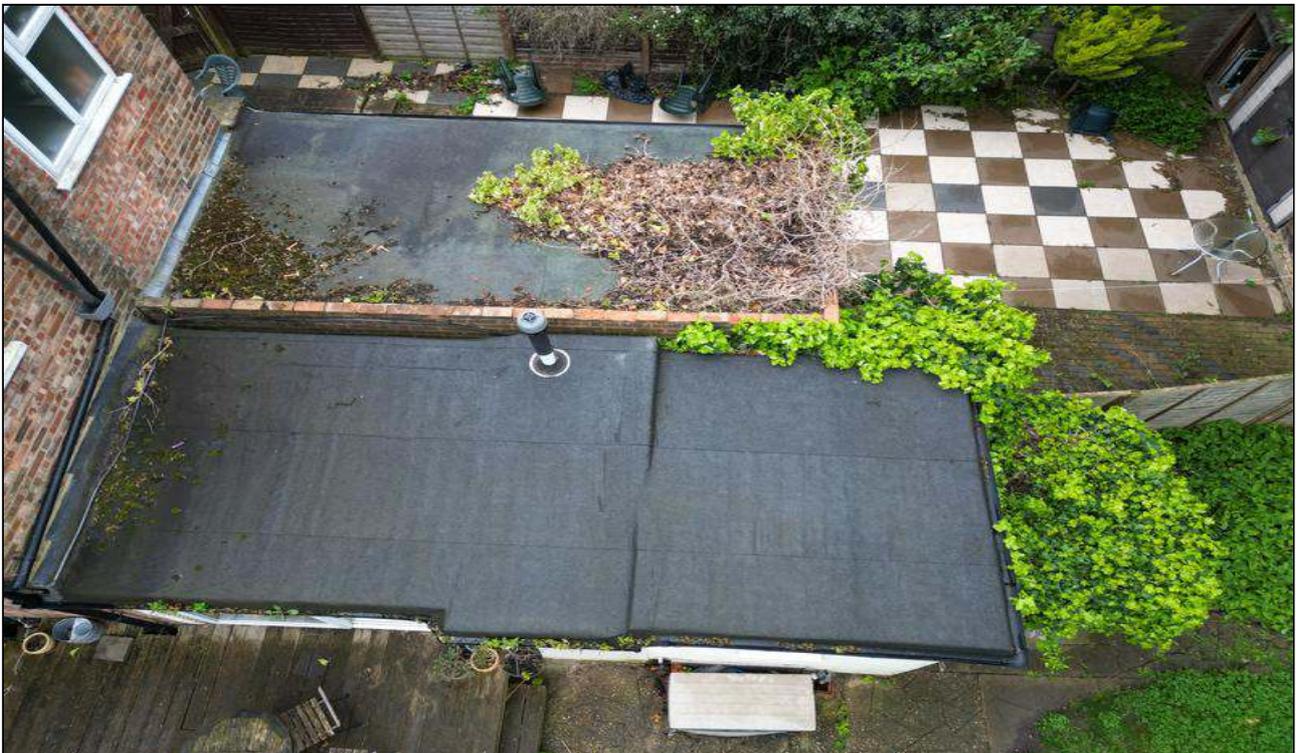
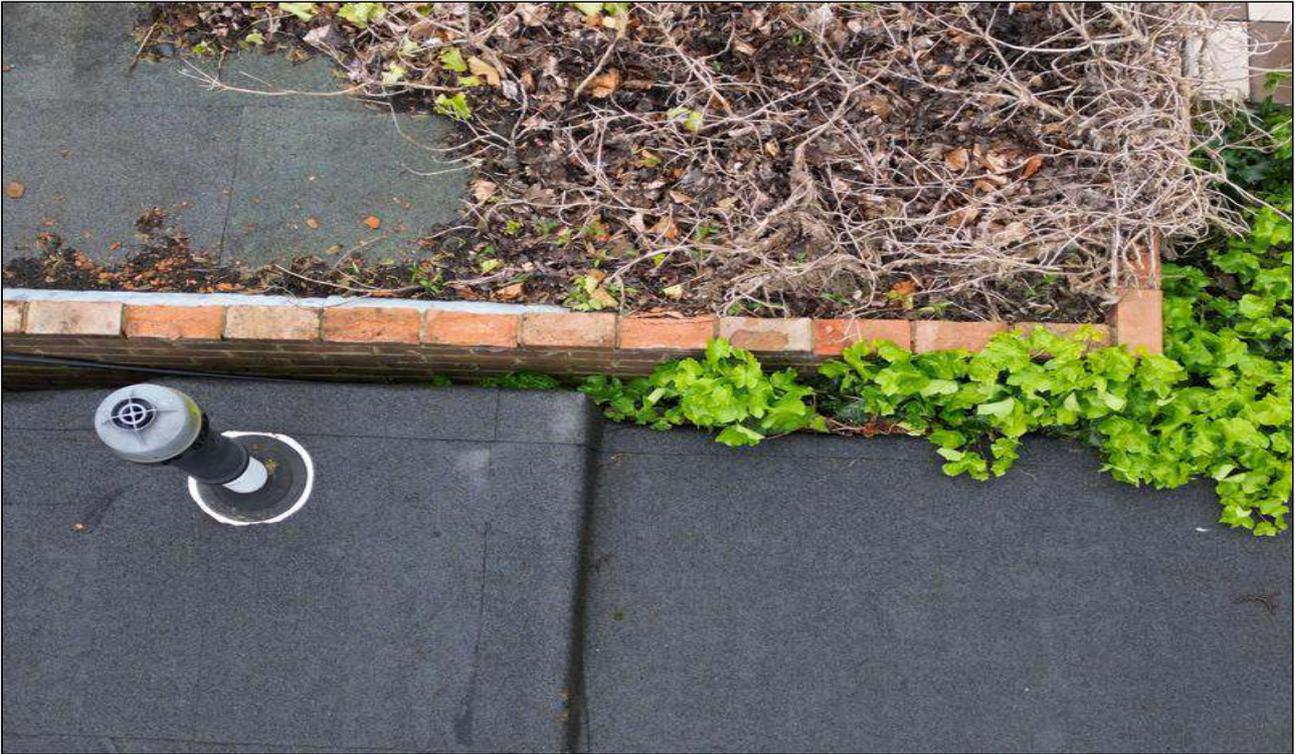
5.2 EXTENSION ROOFS

CONDITION RATING: 3

The rear extension of the property is equipped with a torch-on mineral felt roof covering, which typically offers a life expectancy of up to 25 years, dependent on the brand and adherence to manufacturer's installation guidelines. Despite appearing to be newly installed, the workmanship, particularly the installation of lead flashing over the roof abutments, is substandard. Although currently watertight, there is a risk of future leaks. It is advisable to consider replacing the lead flashing to enhance the roof's durability.

The roof covering is deemed to be in adequate condition with a remaining life expectancy of up to 5 years, assuming proper maintenance. However, due to poor installation quality, ongoing vigilance is necessary. Flat roof structures, such as this one, are prone to sudden failure, which underscores the importance of routine maintenance and monitoring. Potential buyers should be aware of the inherent risks associated with flat roofs, including the need for potential costly repairs.

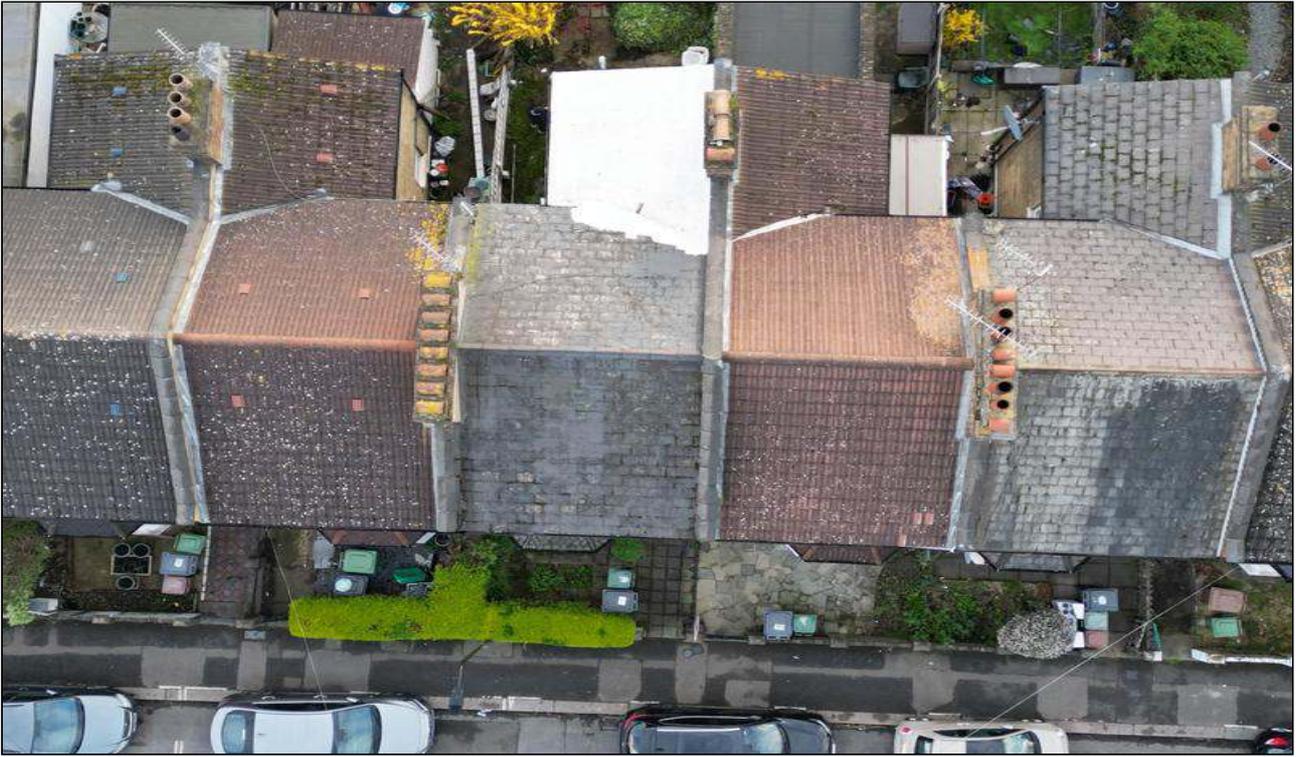
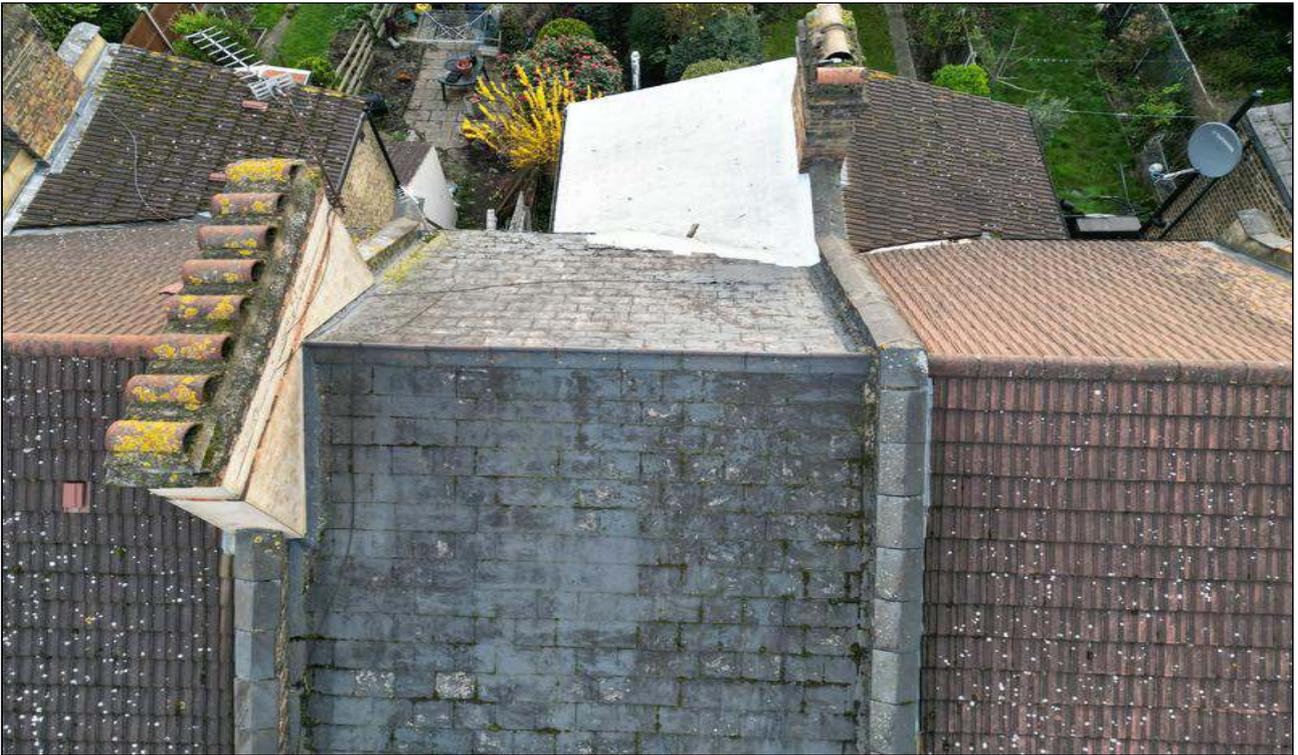
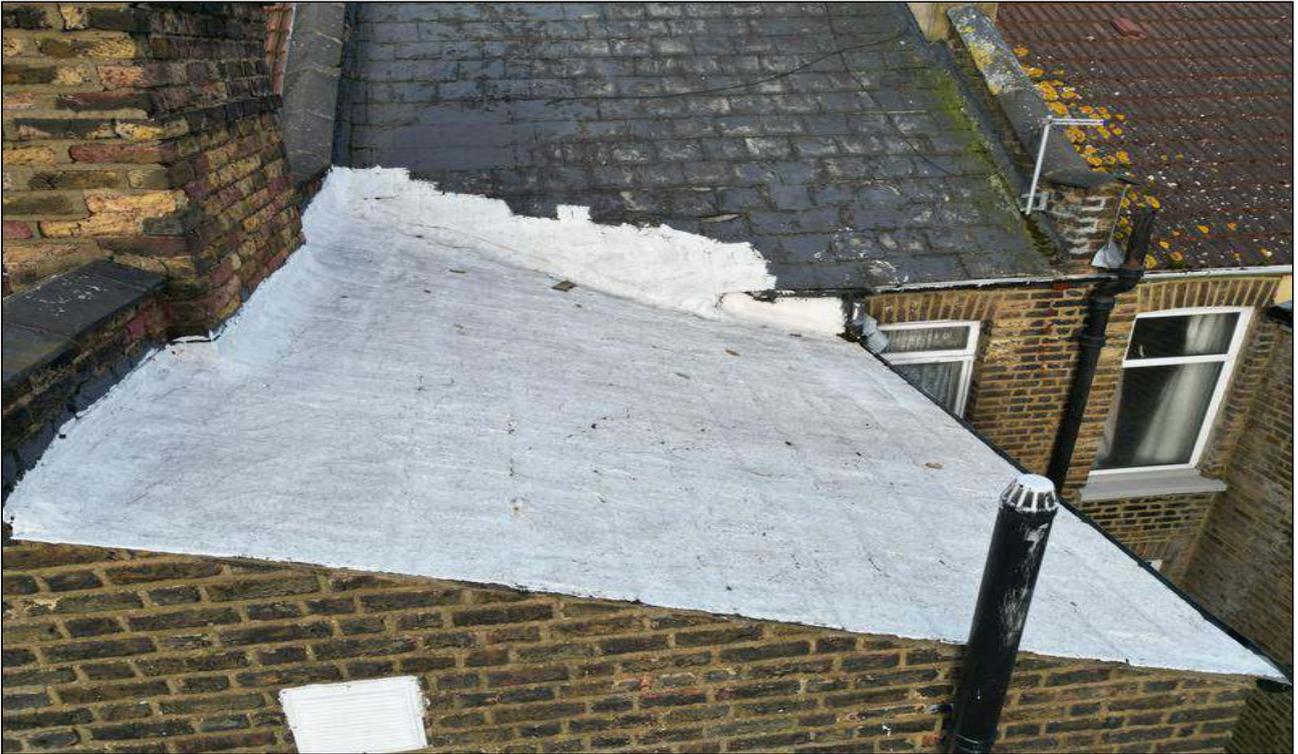
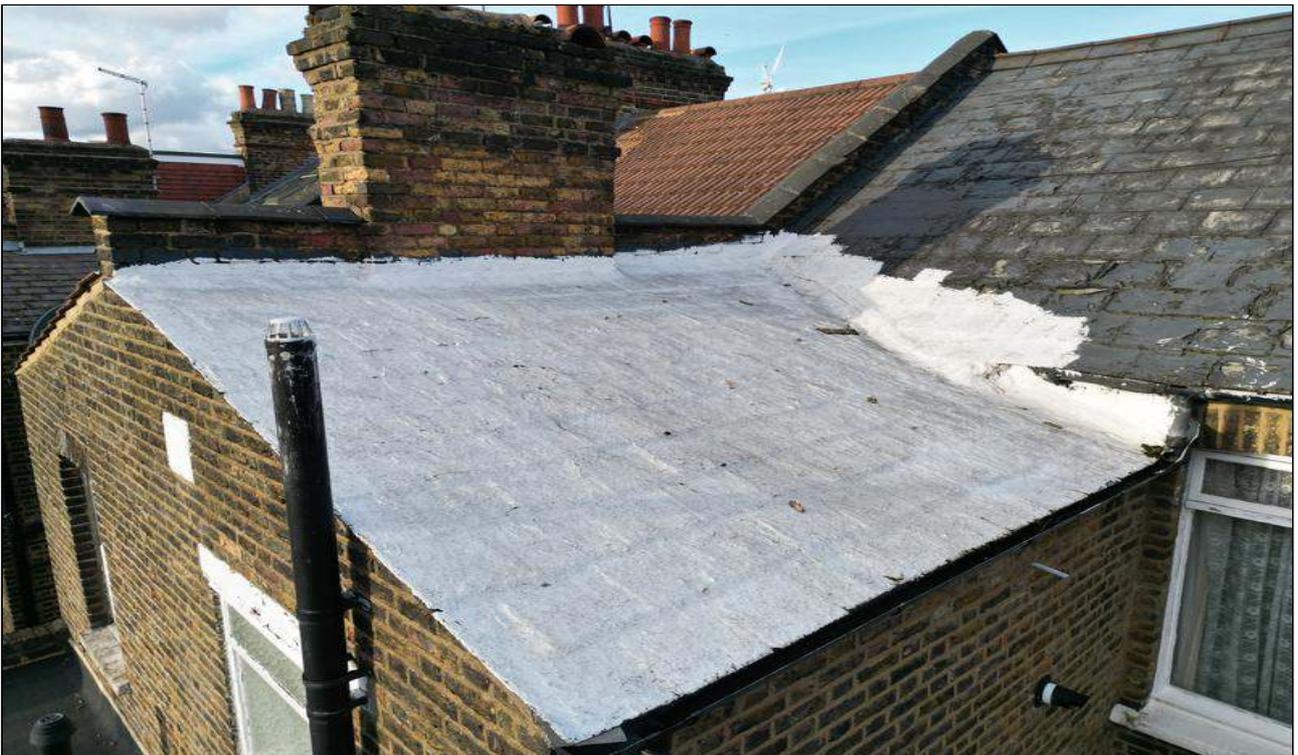
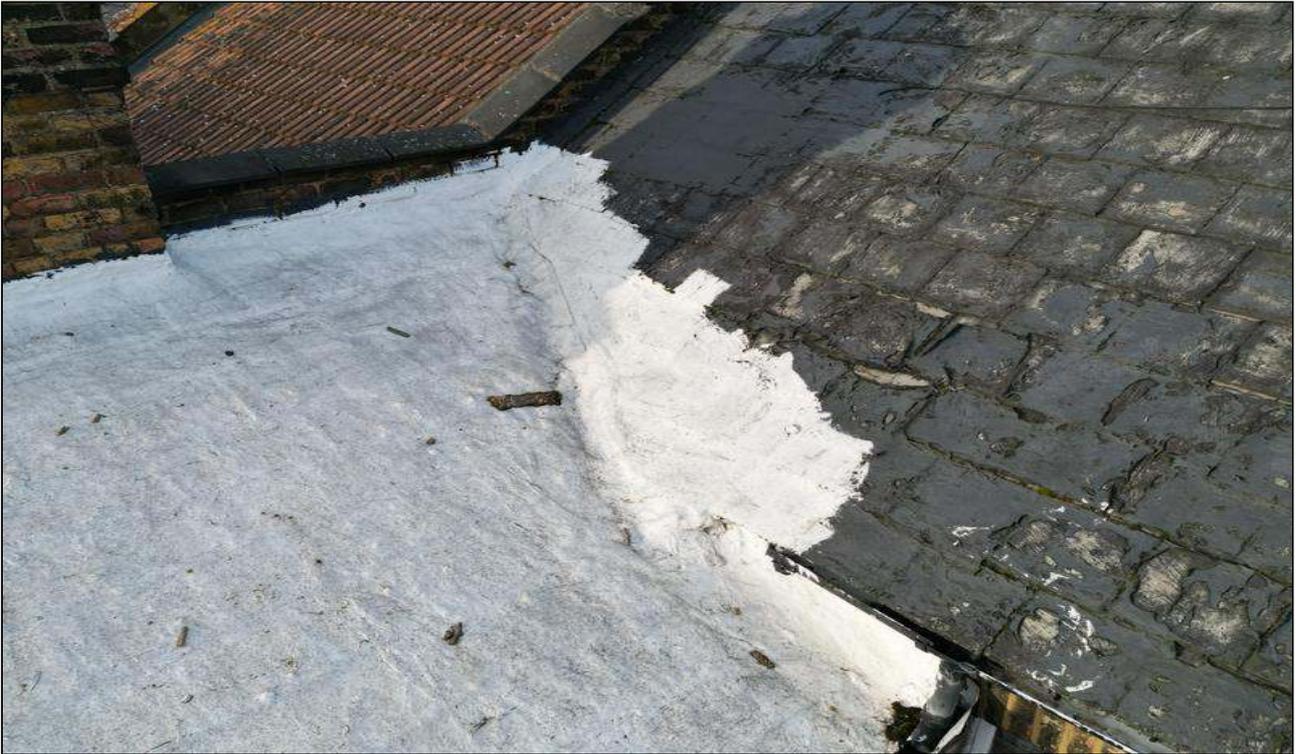
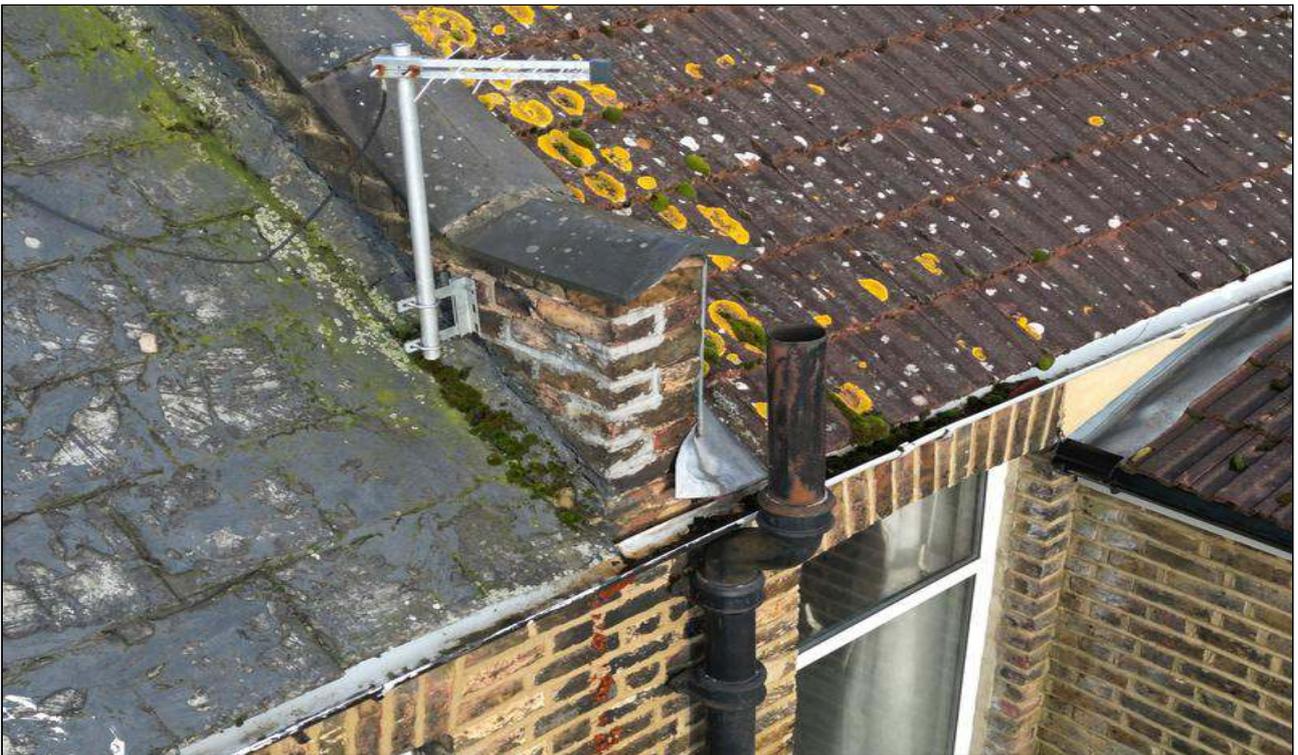
5.3 MAIN BUILDING

CONDITION RATING: 3

The roof of the property, featuring a pitched structure with natural slate tiles, appears to be original and now requires complete renewal. Natural slate typically has a life expectancy ranging from 70 to 100 years, depending on the slate's quality. However, the current condition of the roof covering indicates that it has reached the end of its useful life, with the tiles in poor condition and immediate replacement necessary to prevent potential problems.

The roof's flashing, currently sealed with cement—a less durable and cheaper alternative to more robust materials—also requires immediate attention. It is recommended to replace the existing cement flashing with code four lead flashing or an approved non-lead waterproof flashing material. Similarly, the pointing of the roof is unsatisfactory in parts and needs urgent repair.

Delaying these repairs poses several risks. Deteriorated tiles could become brittle and break, potentially leading to water ingress that causes significant damage and mold growth, which poses health risks. A degraded roof might also become a safety hazard, with loose tiles posing risks to people and property below, especially during adverse weather conditions. Furthermore, the presence of a severely damaged roof could affect the property's insurability, leading to higher premiums or difficulty in obtaining insurance.

It is crucial to replace the roof tiles and repair the flashing and pointing immediately to avoid these risks, ensure safety, and maintain insurance coverage. Failure to address these issues promptly could result in further damage and higher repair costs.

An annual inspection regime is vital to maintain the roof's condition and longevity. Regular checks allow for early detection and correction of minor issues like cracked or missing tiles and weather-related damage. This proactive maintenance helps extend the roof's lifespan, saves on future repair costs, and ensures compliance with insurance requirements. Regular inspections are not only a preventative measure but also a cost-effective approach to managing your property's upkeep.

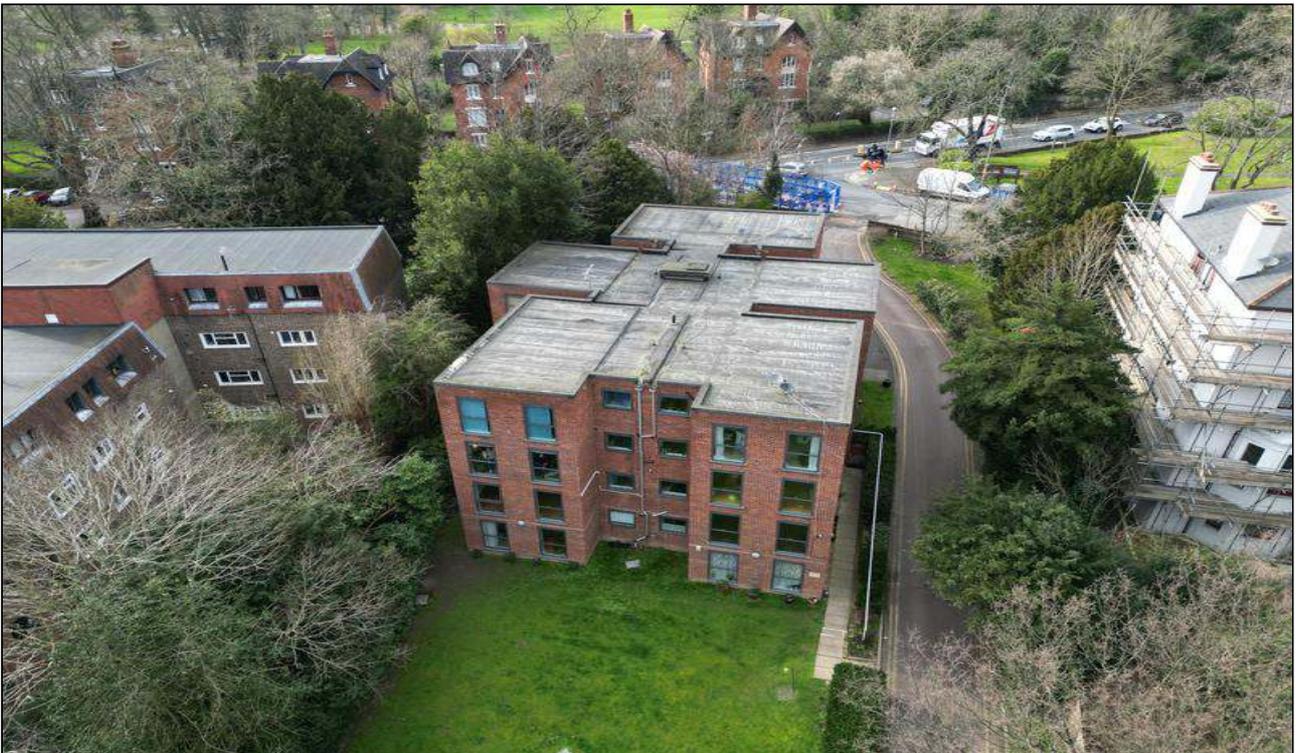
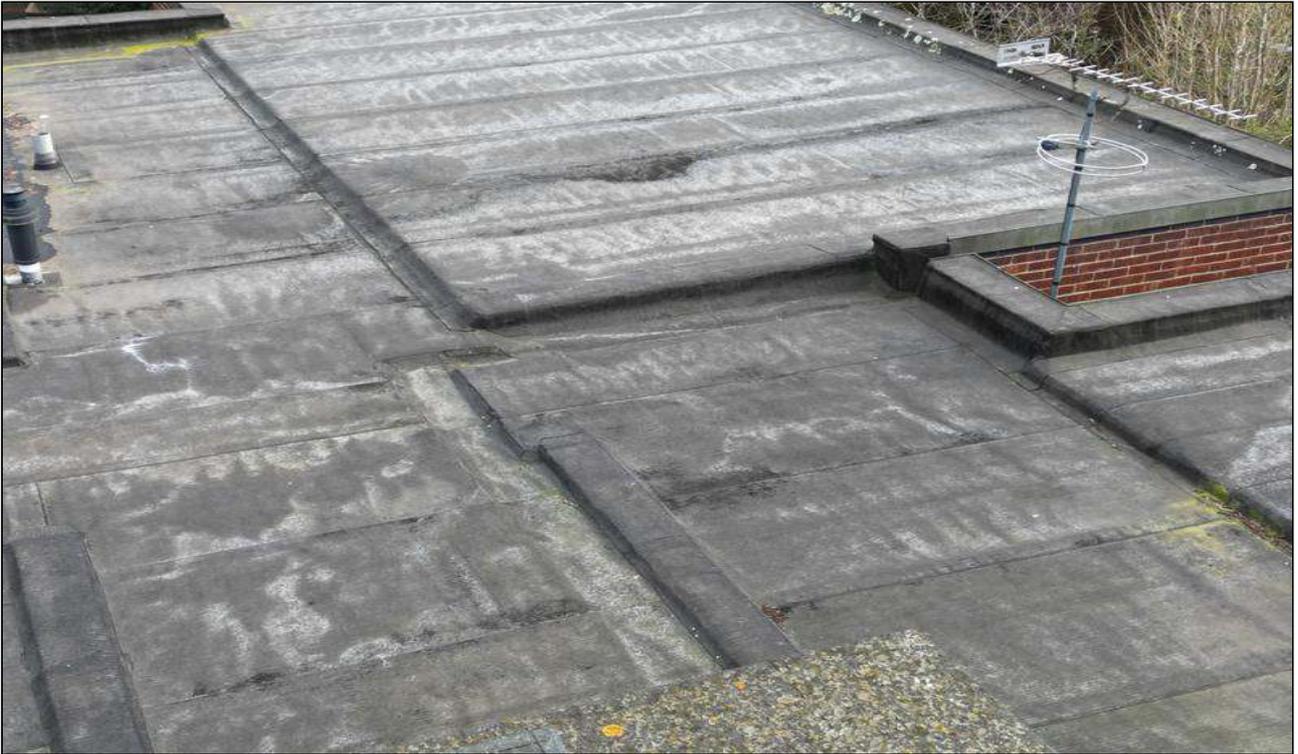
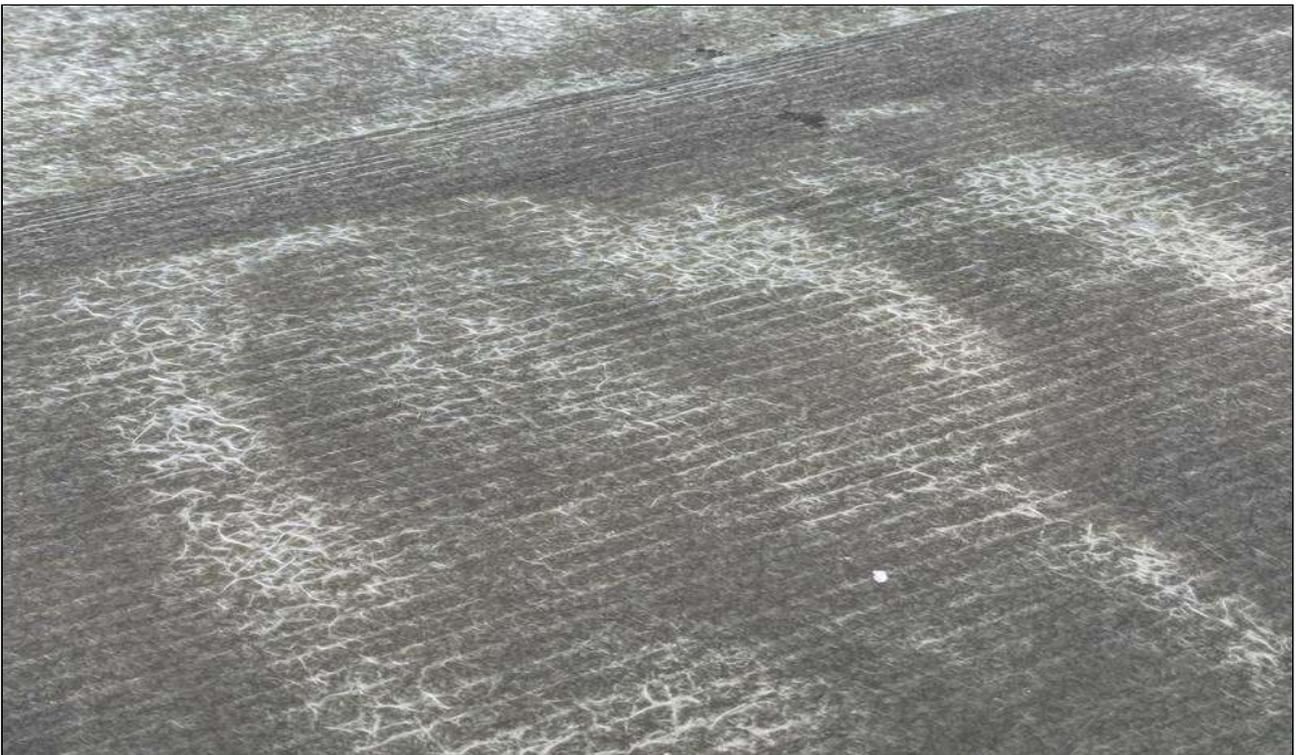
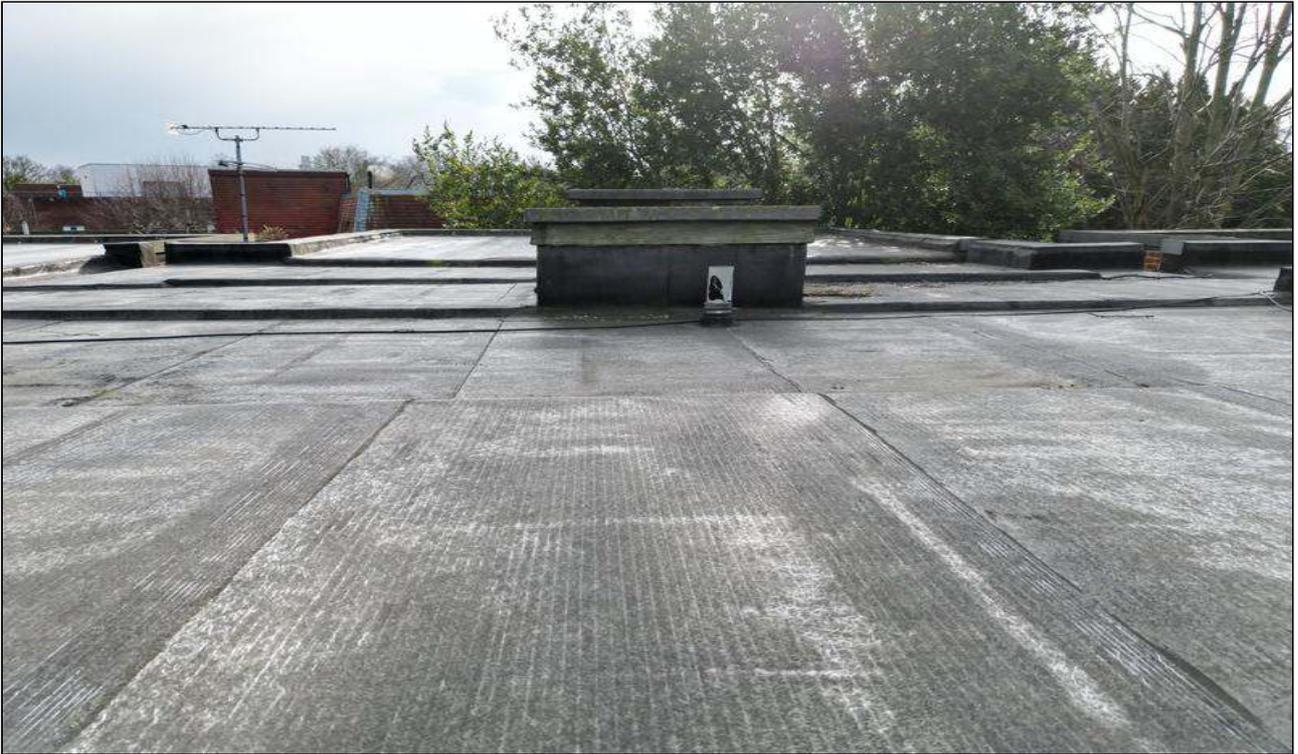
5.4 COMMERCIAL FLAT ROOF - BLOCK

CONDITION RATING: 3

The roof of the property features a flat design covered with mineral felt roofing, which typically offers a life expectancy of up to 25 years, dependent on the manufacturer's specifications and environmental conditions. Current assessments indicate that the roof covering is approximately 30 years old and has surpassed its expected lifespan, rendering it unsatisfactory and in need of immediate replacement.

Given the condition of the roofing material and its age, the estimated remaining life of the roof is assessed at 0 years, indicating that replacement should not be delayed. It is crucial to replace the roofing material now to prevent potential leaks and other related damage that could affect the integrity of the property.

To maintain the condition and extend the lifespan of the new roofing once installed, it is advised to perform annual checks on the roof components. These regular inspections are essential for identifying any early signs of wear or damage, allowing for timely interventions that could prevent more extensive and costly repairs in the future.
